## Fish Passage & Diversion Screening Inventory Database Report Cover Sheet

### Site Description Report

Site ID 105 K060620a

## Level A Culvert Assessment Report

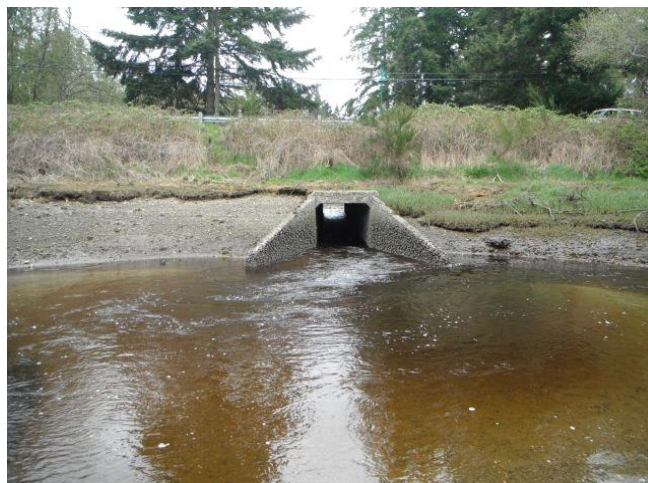
<b>Comments</b>
Tidal culvert. DS end is completely submerged at high tide, barnacles attached to the top. Barrier at low tide levels. BFW taken 150 ft. upstream. Engineer review by WaterFall (Powers) concluded barrier status 80% of tide 3/2015.
